Inspection Report

Atlanta Strip Mall Commercial Building

Property Address:
1385 Highlands Ridge Rd.
Smyrna GA 30082

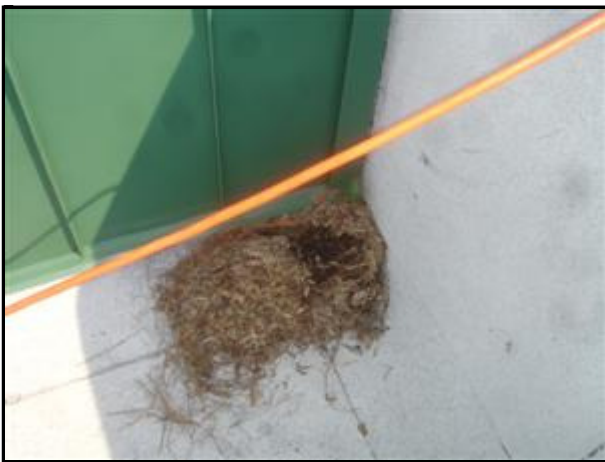
1.0 Picture 1

1.0 (1) Recommend remove all debris from roof.

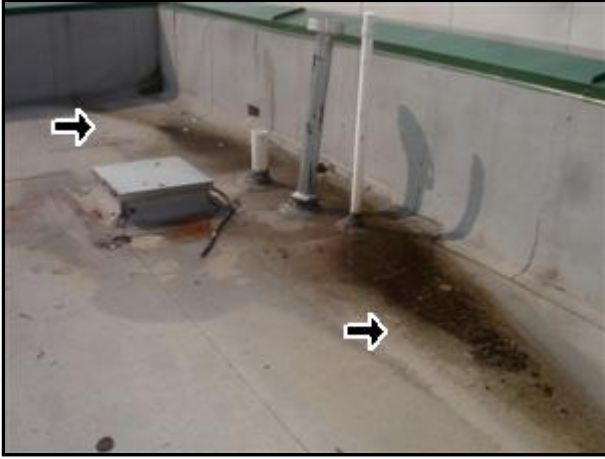
1.0 Picture 2

🏠 (2) Standing water noted at roof mostly at left rear corner of building. Leaking and further damage may occur. Recommend repair by qualified roof contractor.

(2) Standing water noted at roof mostly at left rear corner of building. Leaking and further damage may occur. Recommend repair by qualified roof contractor.
-

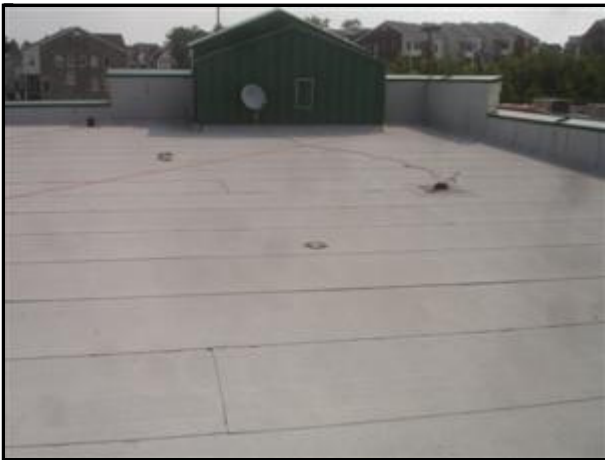
1.0 Picture 3

🏠 (3) Roof covering type for building is known as rolled selvage. Average life span in Georgia is approximately 6-12 years. Some small humps or raised sections were noted and may need repair (recommend further evaluation of these areas when roof contractor makes other know defective repairs). Recommend regular evaluation of roof covering by a qualified roof contractor.

(3) Roof covering type for building is known as rolled selvage. Average life span in Georgia is approximately 6-12 years. Some small humps or raised sections were noted and may need repair (recommend further evaluation of these areas when roof contractor makes other know defective repairs). Recommend regular evaluation of roof covering by a qualified roof contractor.
-

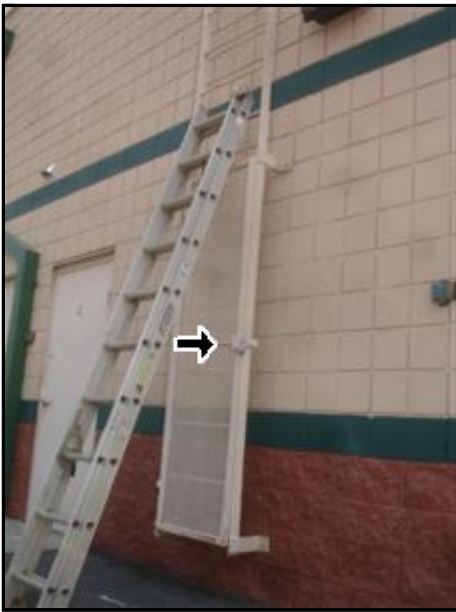
1.0 Picture 4

- 🏠 (4) Rear building roof service ladder was locked. Recommend obtaining key.

(4) Rear building roof service ladder was locked. Recommend obtaining key.

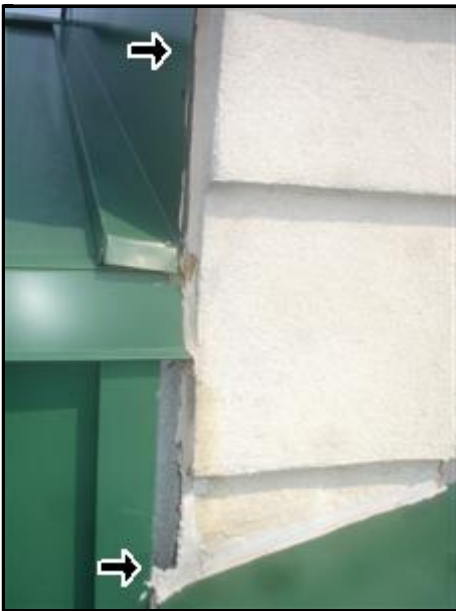
1.1 Picture 1

- 🏠 **1.1** Recommend sealing all transitions at roof such as where metal cap meets stucco cladding and where metal cap meets roof covering. Leaking may occur. Recommend repair by qualified roof contractor.

Recommend sealing all transitions at roof such as where metal cap meets stucco cladding and where metal cap meets roof covering. Leaking may occur. Recommend repair by qualified roof contractor.
-

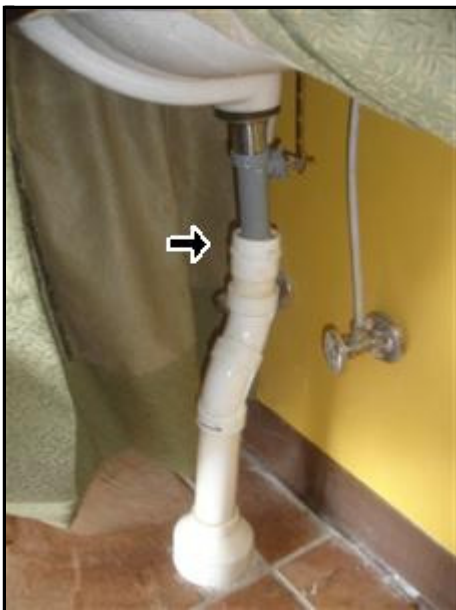
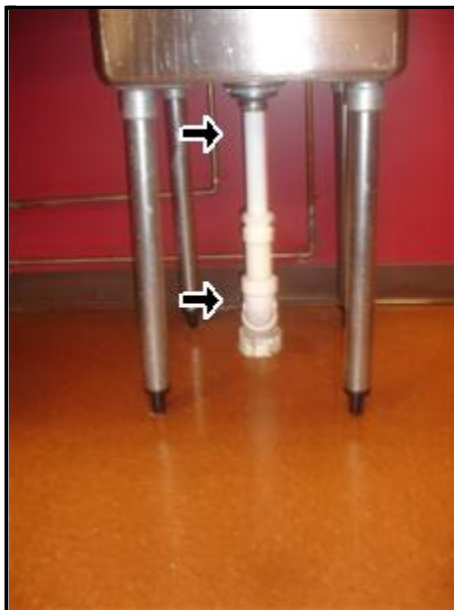
**4.0** (1) Several drain waste lines for sinks did not have visible P-Traps. Recommend repair by licensed plumber.

(1) Several drain waste lines for sinks did not have visible P-Traps. Recommend repair by licensed plumber.
-

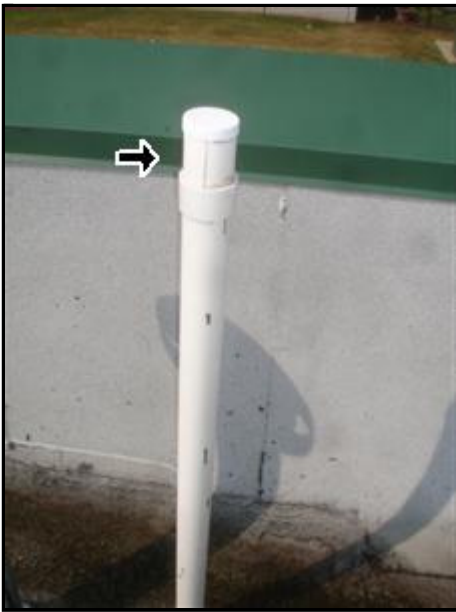
4.0 Picture 3

🏠 (2) Plumbing vent piping was capped off at rear roof of building. Recommend repair by licensed plumber.

(2) Plumbing vent piping was capped off at rear roof of building. Recommend repair by licensed plumber.

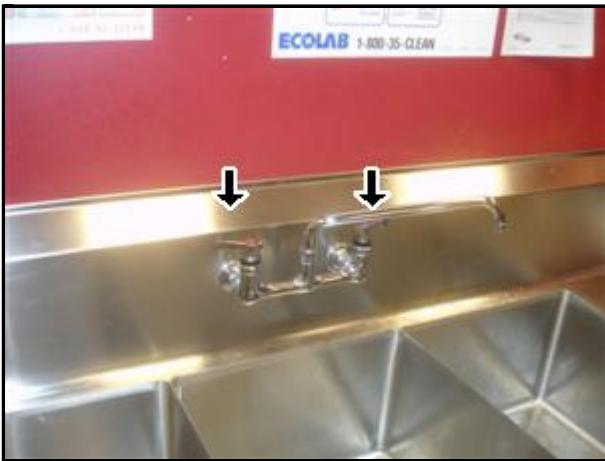
4.1 Picture 1

🏠 **4.1** Bottom element cover for electric water heater was not properly secured. I noted plumbing water piping for hot and cold was reversed at faucets. Cold water produced luke warm temperatures. Recommend further evaluation and repair by licensed plumber.

Bottom element cover for electric water heater was not properly secured. I noted plumbing water piping for hot and cold was reversed at faucets. Cold water produced luke warm temperatures. Recommend further evaluation and repair by licensed plumber.

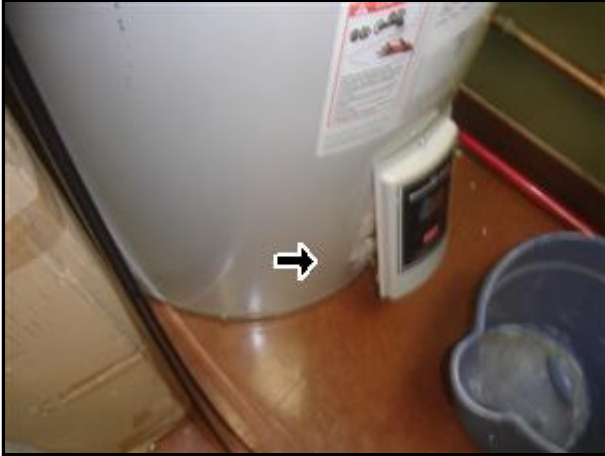
4.2 Picture 1

4.2 Bottom element cover for electric water heater was not properly secured. I noted plumbing water piping for hot and cold was reversed at faucets. Cold water produced luke warm temperatures. Recommend further evaluation and repair by licensed plumber.

Bottom element cover for electric water heater was not properly secured. I noted plumbing water piping for hot and cold was reversed at faucets. Cold water produced luke warm temperatures. Recommend further evaluation and repair by licensed plumber.

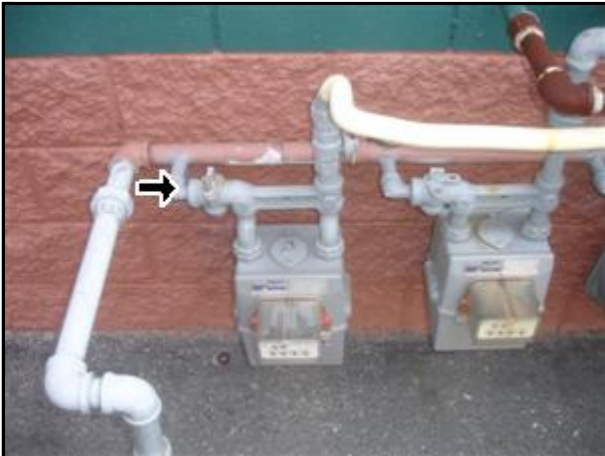
4.4 Picture 1

4.4 Gas was not turned onto building at time of inspection. I could not test any gas operated appliances for proper operation.

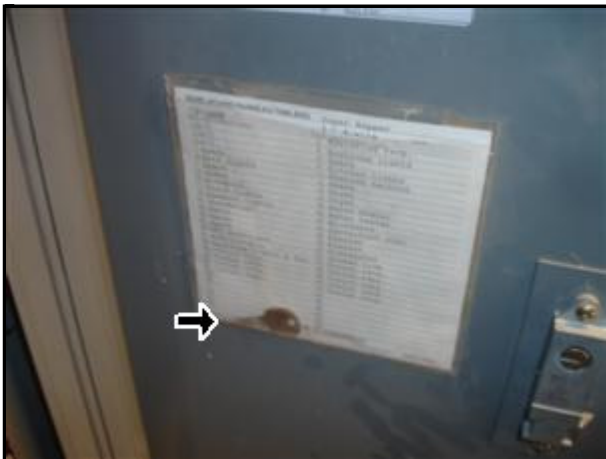
7.1 Picture 1

7.1 Key for electrical access panel (dead cover) was noted inside. Recommend putting key in accessible place if you lock the panel cover.

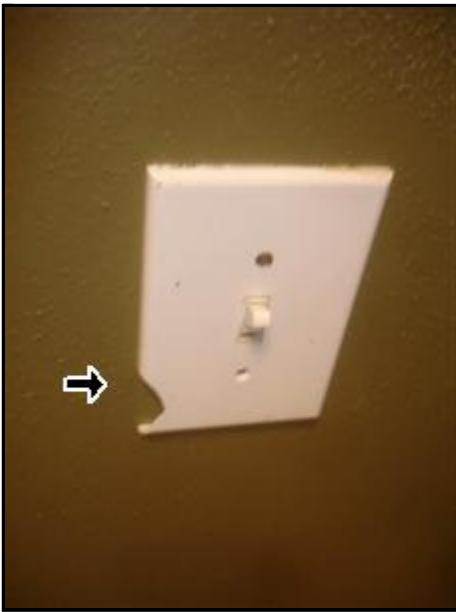
7.3 Picture 1

7.3 (1) Rear private restroom switch plate is damaged. Recommend repair by licensed electrician.

(1) Rear private restroom switch plate is damaged. Recommend repair by licensed electrician.
 -

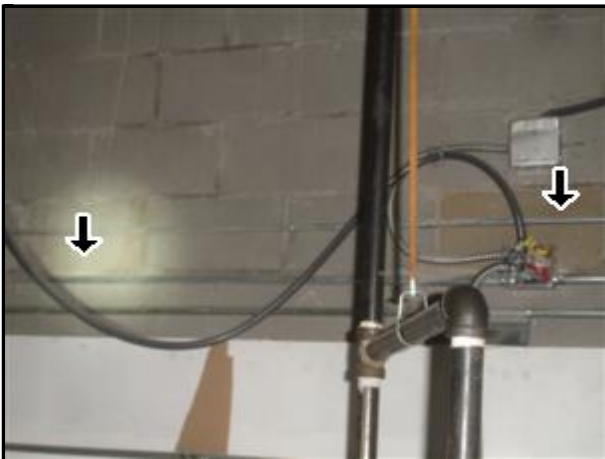
7.3 Picture 2

7.3 (2) Exposed electrical wiring noted in several areas above suspended ceiling inside building. Electrical wiring was also not properly secured. This is a safety issue. Recommend repair by licensed electrician.

(2) Exposed electrical wiring noted in several areas above suspended ceiling inside building. Electrical wiring was also not properly secured. This is a safety issue. Recommend repair by licensed electrician.
 -

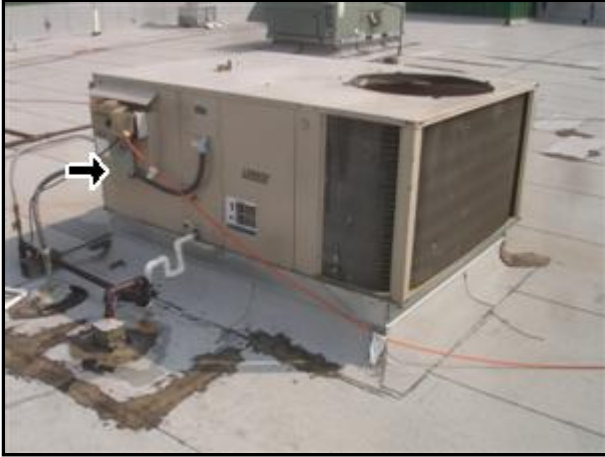
7.3 Picture 3

🏠 (3) Electrical extension cord was plugged into unit B HVAC system on roof. This extension cord is hanging unplugged at the front of your building. Recommend remove extension cord.

(3) Electrical extension cord was plugged into unit B HVAC system on roof. This extension cord is hanging unplugged at the front of your building. Recommend remove extension cord.
-

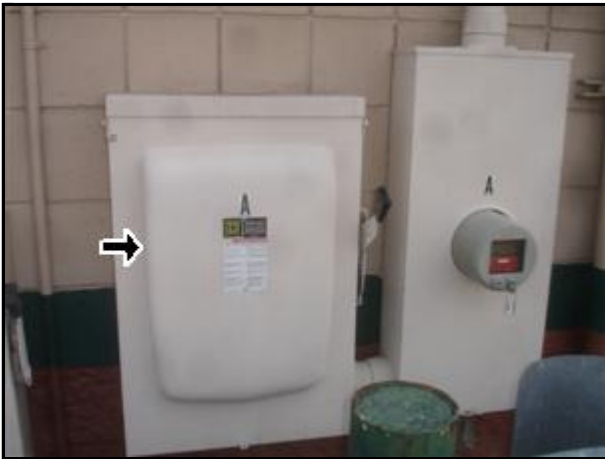
7.6 Picture 1

7.6 The main panel box is located in kitchen area inside. However, the main disconnect (shut-off) is outside at meter base panel (Your unit A for your information).

I was not able to open the main disconnect cover (painted shut) recommend making main disconnect accessible.

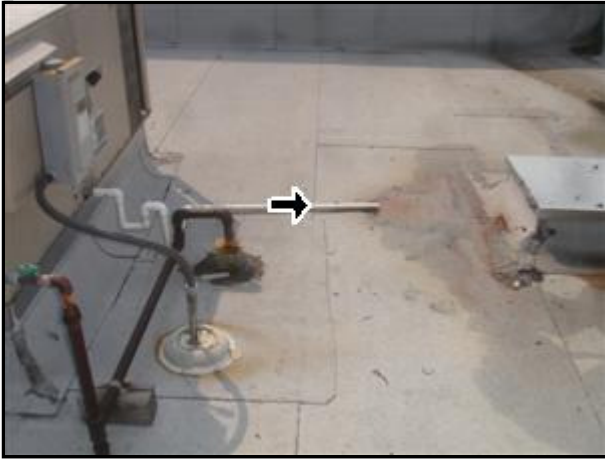
8.2 Picture 1

8.2 Condensation piping for HVAC unit drains directly onto roof. Recommend extend piping to side of building. Further damage may occur. Recommend repair by licensed HVAC contractor.

Condensation piping for HVAC unit drains directly onto roof. Recommend extend piping to side of building. Further damage may occur. Recommend repair by licensed HVAC contractor.

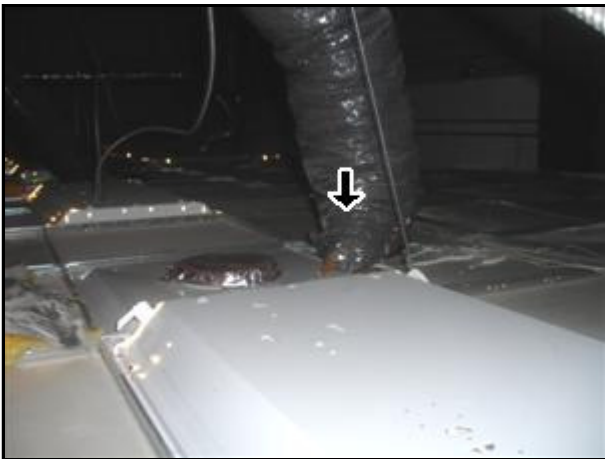
8.6 Picture 1

8.6 HVAC duct piping was not properly connected to register vents (partially closed off). Energy loss is occurring and condensation may cause damage. Recommend repair by licensed HVAC contractor.

HVAC duct piping was not properly connected to register vents (partially closed off). Energy loss is occurring and condensation may cause damage. Recommend repair by licensed HVAC contractor.

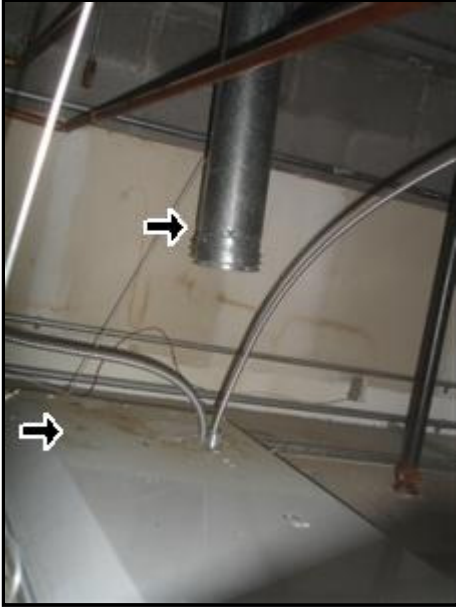
8.7 Picture 1

8.7 Flue piping was installed for a gas water heater, however an electrical water heater is currently being used. Some water stains/leaking was noted. Recommend removing or properly sealing off flue pipe by qualified contractor.
